# Manhole Inspection Summary

Manhole # S27CC\_040MH

Insp Date: **7/7/08 8:34 AM**

**Location** Address: **611 W LAFAYETTE AVE**

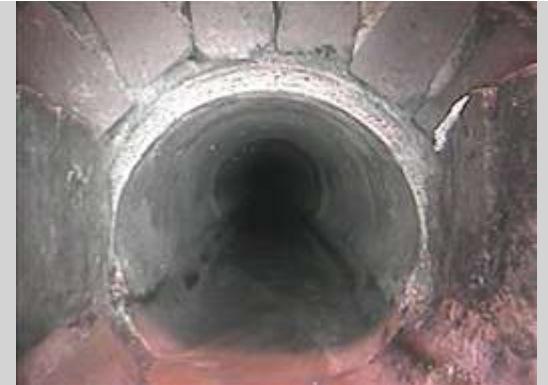
12 O'Clock Outflow

8 in. Circular Gravity Sewer  
Pipe Out @ 12 O'Clock

Pipe Material: **Clay** ☐ Pipe Lined

Invert Depth: **9.17** (ft.) Flow Characteristics: **Slow**

Infiltration: **None** Pipe Seal Cond: **Sound**

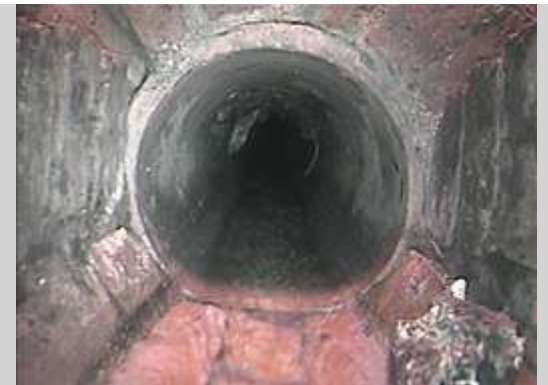
6 O'Clock Inflow

8 in. Circular Gravity Sewer  
Pipe In @ 6 O'Clock

Pipe Material: **Clay** ☐ Pipe Lined

Invert Depth: **9.15** (ft.) Flow Characteristics: **Slow**

Infiltration: **None** Pipe Seal Cond: **Sound**

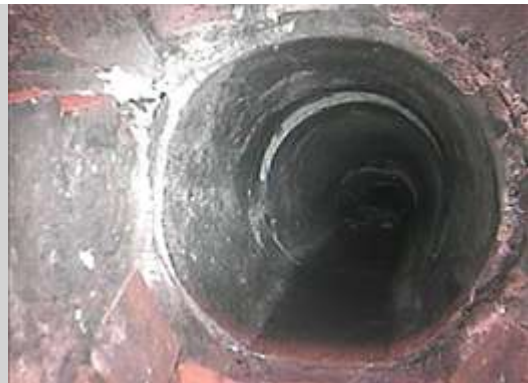
9 O'Clock Inflow

8 in. Circular Gravity Sewer

Pipe In @ 9 O'Clock

Pipe Material: **Clay** ☐ Pipe Lined

Infiltration: **None** Pipe Seal Cond: **Sound**
